The Safety and Enforcement Division (SED) of the California Public Utilities Commission conducted a G.O. 112, Operation and Maintenance Inspection of Southern California Gas Company's (SoCalGas) Mountain Pass Distribution Area from April 8, 2019 to April 19, 2019. The inspection included a review of both companies' written O&M procedures pursuant to G.O. 112-F, Reference Title 49, Code of Federal Regulations (CFR), Parts 191, 192 and 193

2019 SoCalGas Mountain Pass Distribution Area
4/8/2019 to 4/19/2019

Notice of Probable Violations

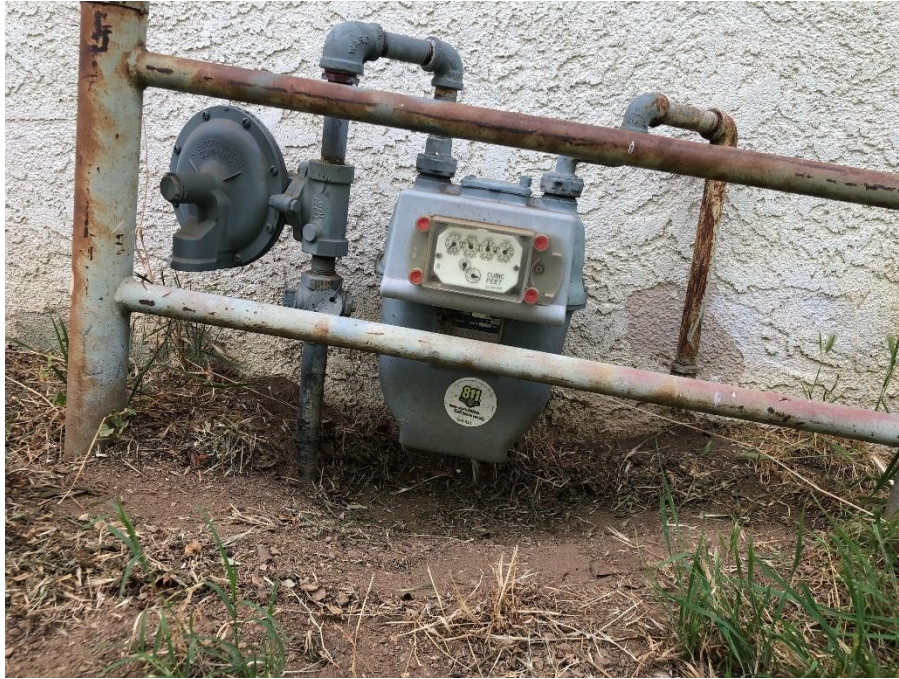
5. During the field inspection, SED observed that an aboveground customer Meter Set Assembly (MSA) -Aluminum case meters was touching/in contact with dirt at test station location’s CVLY7 CP point read A and at 35438 Wildwood Canyon Rd. SCG’s Gas Standard 185.0001 Condition/Location of Meter Installation and Report of Inaccessible/Removed Meters, Section 3.7 requires this potentially hazard condition to be addressed and corrected. SED recommends that SCG take remedial action to address SED’s concern.

According to SoCalGas CP records, as well as notes from the 2019 Mtn. Pass CPUC SED inspection, the correct address for CVLY7 read point “A” is 38961 Lewis Ct. in Cherry Valley. Additionally, Gas Standard 185.0001 is titled *Meter Location and not Condition/Location of Meter Installation and Report of Inaccessible/Removed Meters* as referenced by SED. Additionally, Gas Standard 185.001 makes no reference to MSAs in contact with the ground.

38961 Lewis Ct. / Dirt cleared from below MSA

SoCalGas acknowledges that CP employees conducting field activities that involve observing a customer above ground MSAs should understand the need to identify, report and when possible correct a potential unsatisfactory condition. SoCalGas will share this information with Gas Operations System Protection employees system wide. A SoCalGas technician immediately cleared the dirt from below the MSA during the inspection.

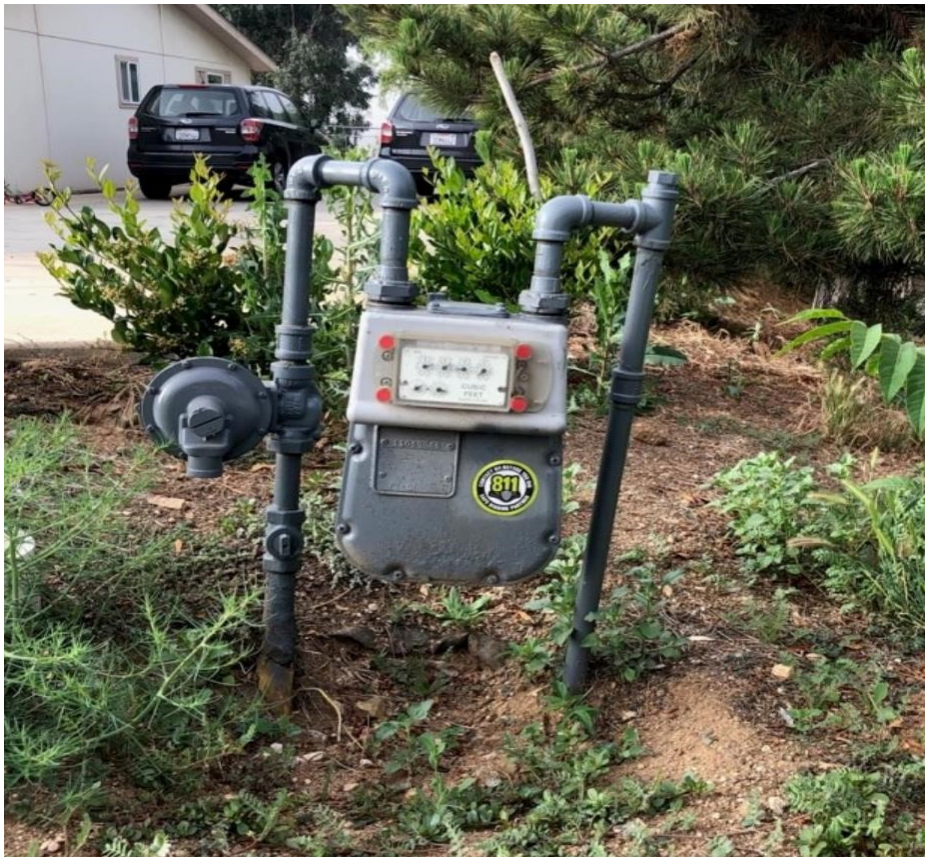
6. During the field inspection, SED observed SCG’s employee performing a leak survey. SED made him aware of an MSA touching/in contact with dirt. In addition, he failed to take the necessary steps to the address this condition as an AOC described in SCG’s Gas Standard 223.0100, Leakage Surveys, Section 7, that requires a leak surveyor to issue order for corrective actions. SED recommends that SCG take the necessary steps to ensure its employees adhere to its Gas Standards when performing O&M activities.

Furthermore, an Abnormal Operation Condition (AOC) was not at issue. Section 4.11 / ***Abnormal Operating Conditions*** of Gas Standard 223.0100 references that a meter that is “buried” in earth is an AOC. The meter observed during the audit was not “buried” at the time of the inspection and was only observed to be “touching” the bottom of the meter.

35451 Wildwood Canyon / Raised MSA

SoCalGas does acknowledge that the survey technician could take note of these types of conditions to prevent the meter from potentially becoming buried in the future. The individual technician, and the San Bernardino gas operations employees, were reminded of their responsibilities in recognizing and reporting AOCs while conducting leak surveys per Gas Standard 223.0100 Section 4.11. Additionally, SAP work order #5200002068733 was issued for the address of 35451 Wildwood Canyon to raise the meter. This work was completed on April 18, 2019. See picture attached in **Appendix**.

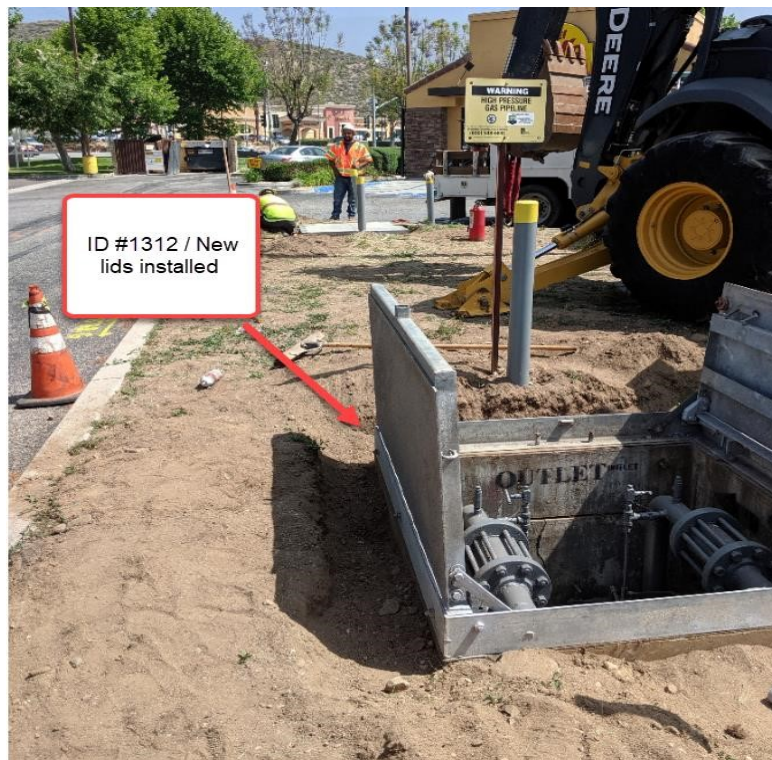
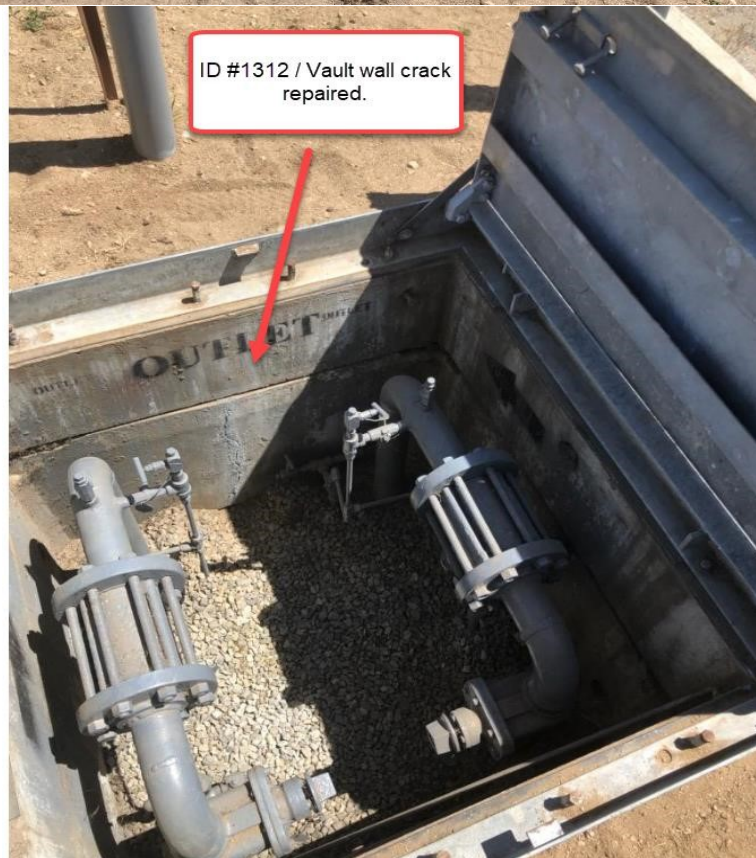
7. During the field inspection, SED observed that vault #1312 had cracks on the concrete walls within a regulating station. In addition, the vault's cover/lid had a broken spring support. SCG's Gas Standard 223.0210, Vault Maintenance and Inspection, Section 4.6, requires employees to contact the Mechanical, Civil and Structural Design Group in Engineering Design to assess the integrity of the structural condition of the vault for such conditions. SED recommends that SCG take remedial actions to address SED's concerns.

SoCalGas recognized the conditions identified by SED. However, the conditions identified within the vault were considered minor cracks and did not warrant contacting the Mechanical, Civil and Structural Design Group in Engineering Design. There was no exposed rebar or presence of large crushed concrete, as provided in Section 4.6:

ID #1312 – New lids and patched walls

SoCalGas takes the safety of their employees and assets very seriously and SAP Work Order 540000329706 was initiated to replace the vault lids and repair the crack on the vault wall. On June 10, 2019 a third-party construction crew replaced the lids and patched the vault wall. Pictures of completed work can be found in the **Appendix**.
